The Sheraton Grand London Park Lane is located in the heart of Mayfair, London. Its art déco interior and ideal location are adored by thousands of visitors each year.

On the 31st March 2019, the ceiling of the stunning Silver Gallery collapsed due to a burst water pipe causing severe damage to the gallery fabric and decoration.

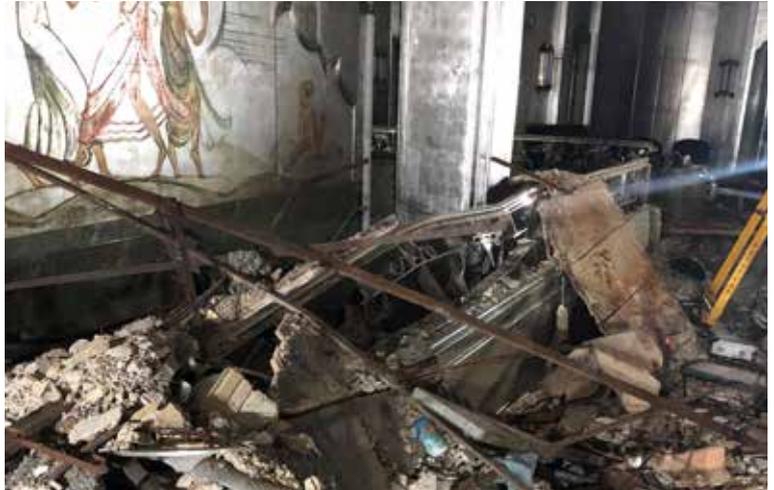
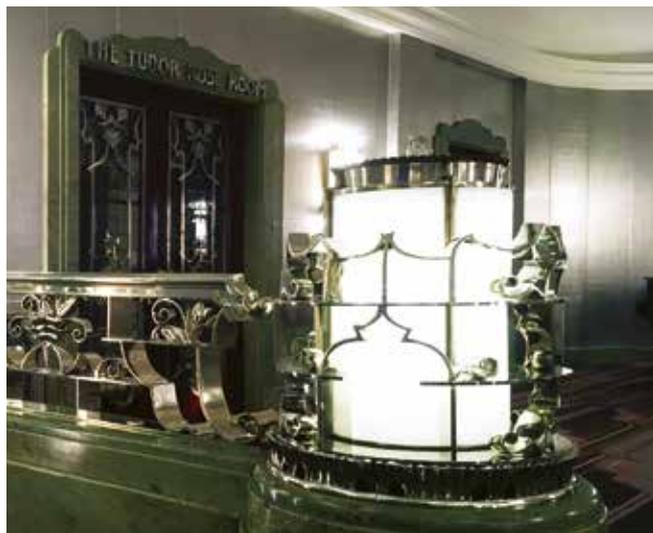
Completed in 1927, the gallery centrepiece is its magnificent, polished nickel-silver balustrading and handrails with matching lanterns that bore the brunt of the ceiling impact damage; extending downwards over eight flights of stairs accessing first the balcony level and then the ballroom.

The gallery level balustrades and lanterns are made up of over 650 separate casts and fabricated pieces of solid nickel-silver, held together with more than 2600 minute nickel-silver machine screws. The balustrade had to be dismantled entirely, components repaired or replaced as necessary, deep-cleaned, polished and rebuilt ready for installation.

In addition to this work, we were instructed to remove, refurbish, deep clean and polish the remaining six flights of balustrading from the lower levels to create a seamless effect to the major restoration works.
